Sample Report

Tuesday, 02 November 2021

78 Issues Identified

New Build Inspections

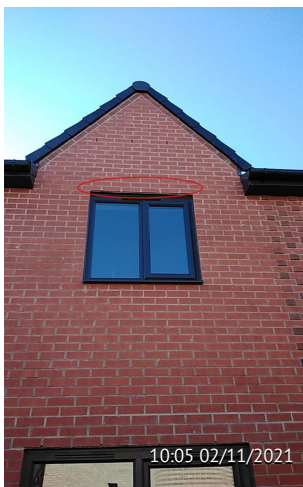
Exterior Front

Blocked weep vents

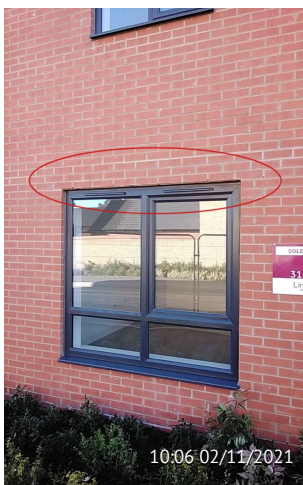
Exterior Front

Cracked mortar above window little allowing for the potential of water ingress.

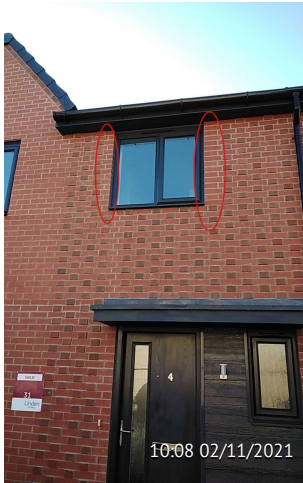
Exterior Front

When compared with the neighbouring property the brickwork around the window hasn't been well planned and is not good practice

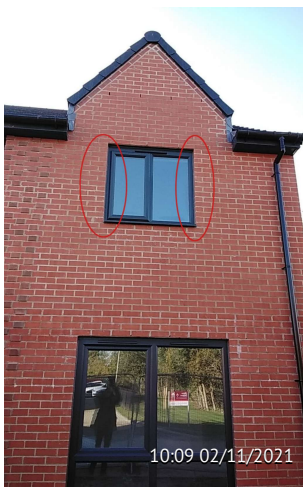
Neighbouring Property

Image of brickwork to neighbouring property

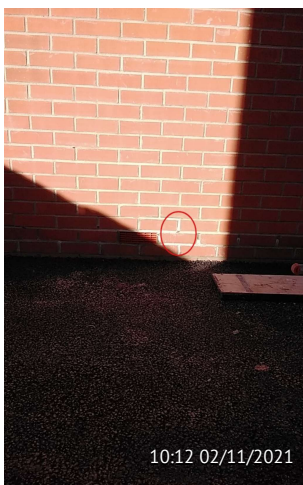
Exterior Left

Blocked weep vent

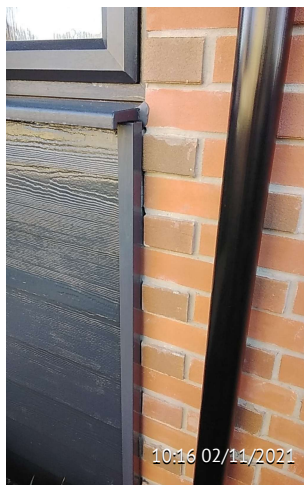
Exterior Front

Opportunity for water ingress around front door cladding

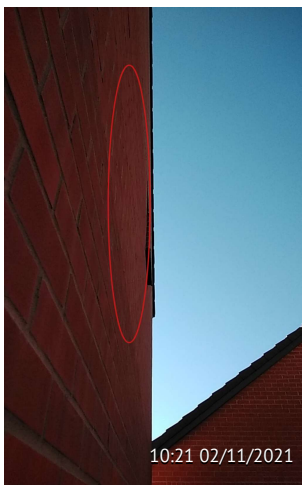
Exterior Right

Slight bulge in brickwork to the right-hand side of the window.
However, it is within NHBC tolerance.

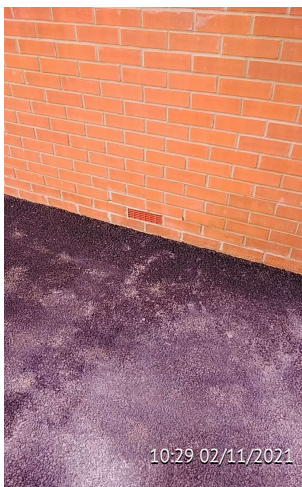
Exterior Right

Driveway too high in relation to the DPC

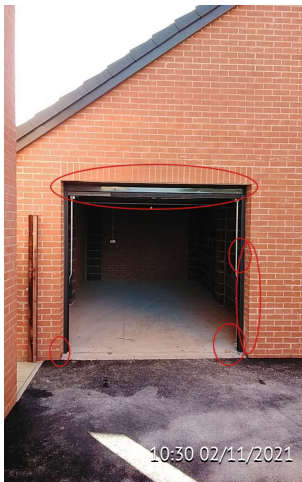
Garage

Plastic protective strip has been left on the garage door

Visible packing pieces to the bottom of the door

Pointing required to DPM to the left of the garage door

Chipped brick to the right-hand side of garage door

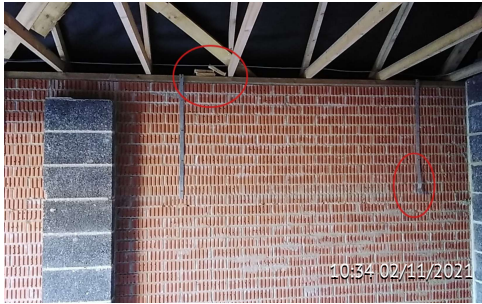
Garage

This is a single skin garage wall and therefore will become damp during periods of rain. Please ensure all belongings stored in the garage are away from the walls and off the floor

Please secure the restraint strap

Please remove timber squares

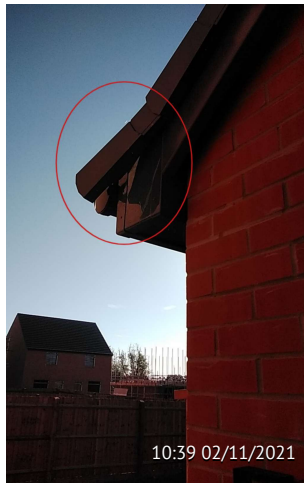
Exterior Rear

Dry verge requires securing

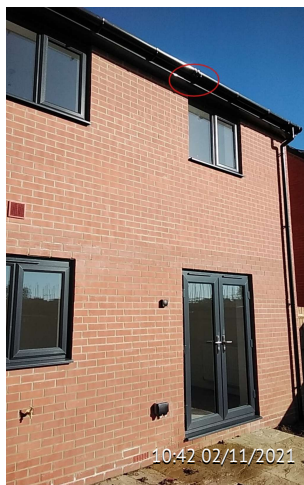
Exterior Rear

Leaking gutter joint

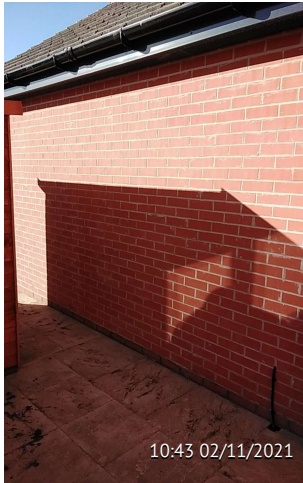
General Comment

Brickwork requires cleaning to garage left-hand side, rear and rear elevation of the house

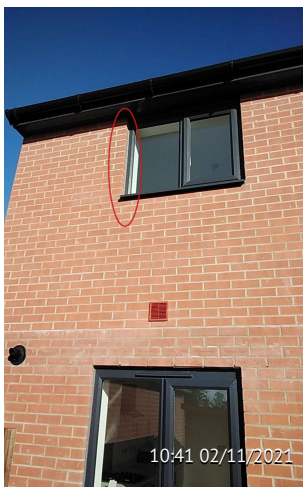
Exterior Rear

Scratch to the top left window frame

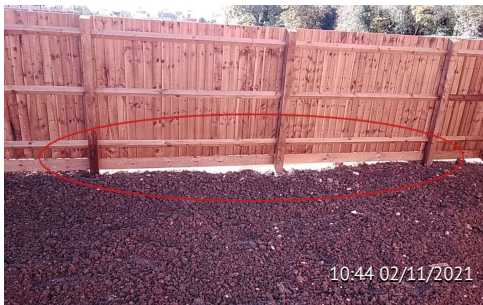
Exterior Rear

Large gap to the bottom of fencing. Additional gravel board required

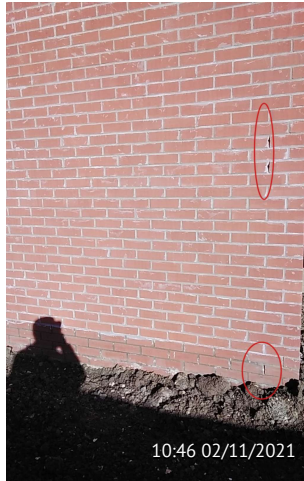
Exterior Rear

Pointing to brickwork required to rear of the garage

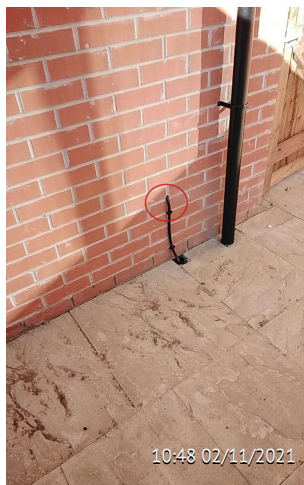
Exterior Rear

Hole for electrical supply to garage requires filling

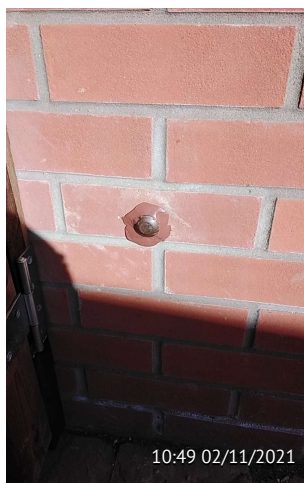
Exterior Rear

Condensate pipe completely sealed allowing no opportunity for water to escape

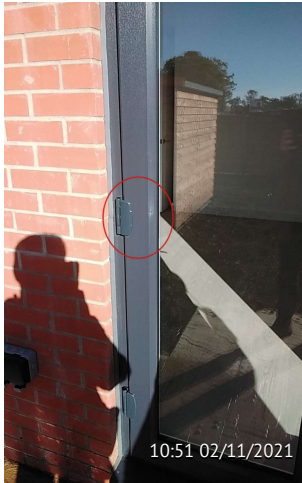
Exterior Rear

Damage to French doors

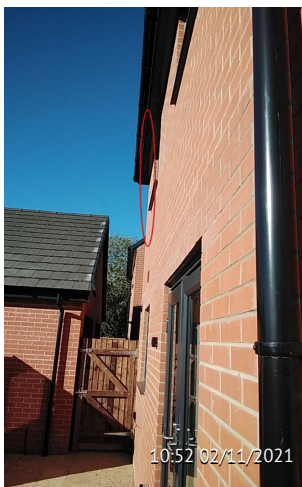
Exterior Rear

Leaning brickwork to the left-hand side window.

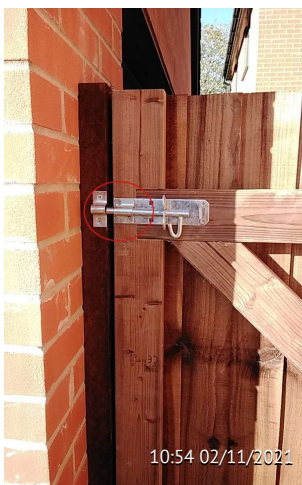
Exterior Rear

Gate bolt does not line up with the latch

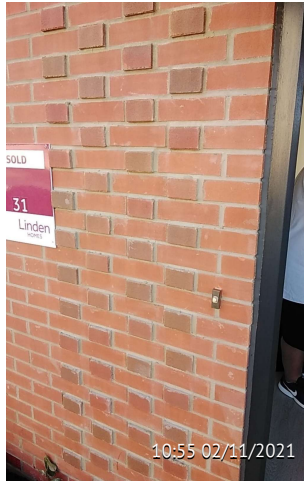
Exterior Front

Mortar snots on brickwork detail require removal

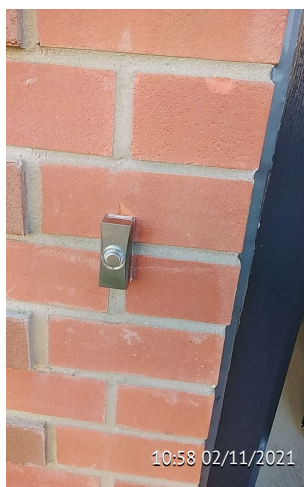
Exterior Front

Doorbell sound not functioning correctly

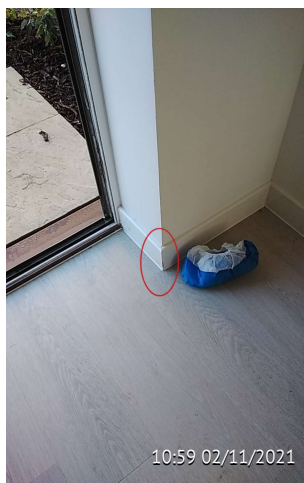
Hallway

Marks to skirting

Generally, the skirting to the hallway should have been cleaned before handover

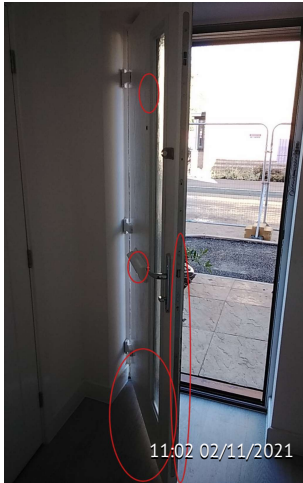
Hallway

Marks to door

Chip on edge of letterbox

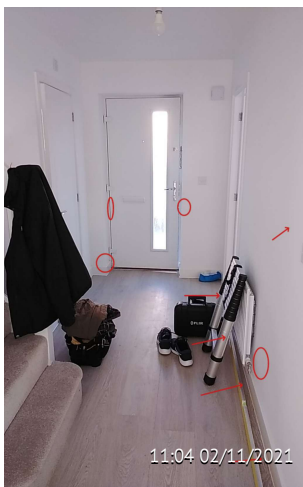
Hallway

Multiple decorative marks to the wall and gloss work. Too many to mention individually builder please check all walls

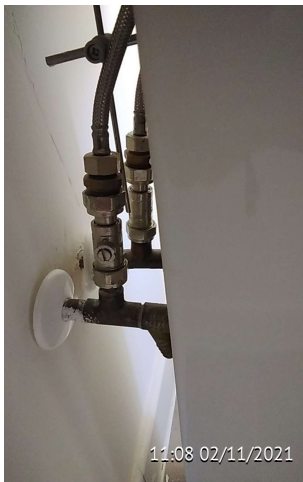
Downstairs WC

Loose unclipped pipework to basin water feeds

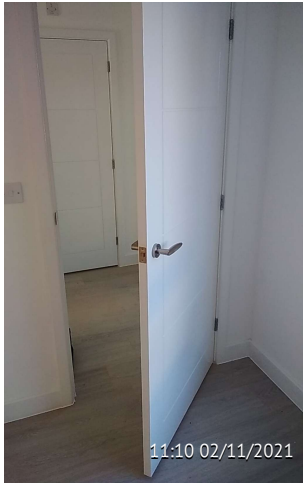
Sitting Room

Door rattles in its frame

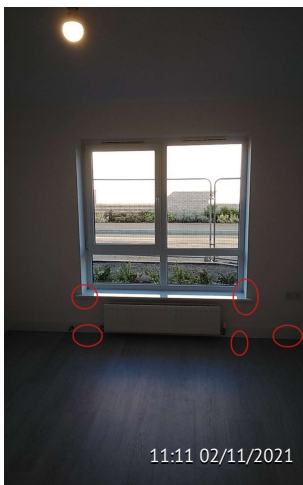
Sitting Room

Marks to wall

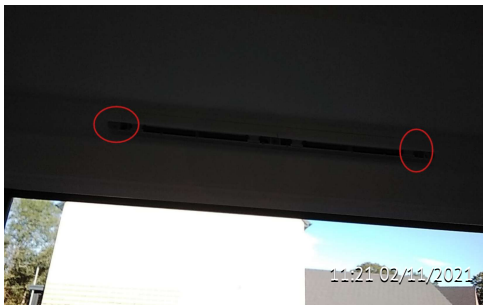
Sitting Room

Screws missing to both window trickle vents

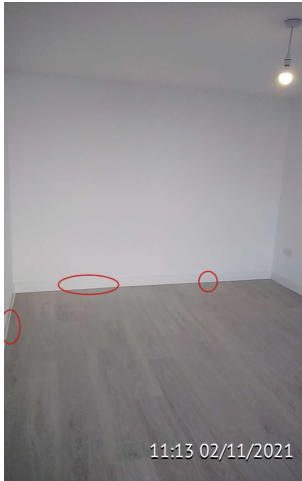
Sitting Room

Marks to skirting

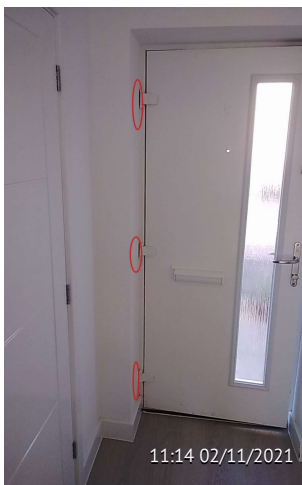
Hallway

No mastic seal behind door hinges

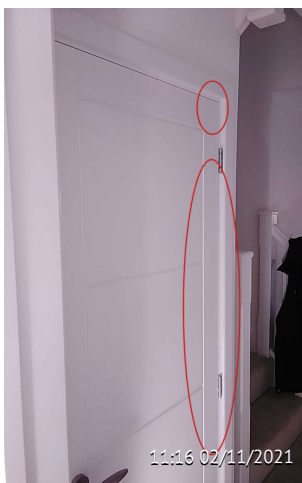
Hallway

Poor decorative finish to door

Door rattles in its frame

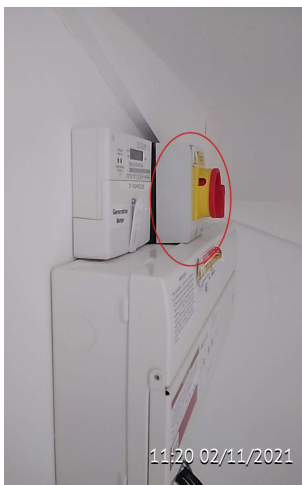
Hallway Cupboard

Loose cover plate to PV isolator

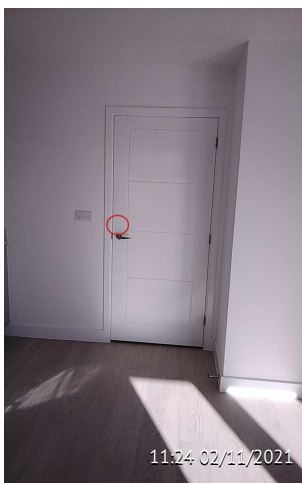
Kitchen

Door rattles in its frame

Marks to door

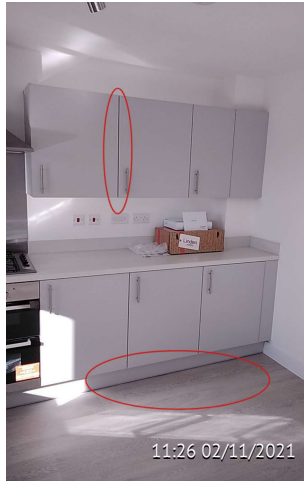
Kitchen

Insufficient clips to kickboard
The kitchen door requires adjustment

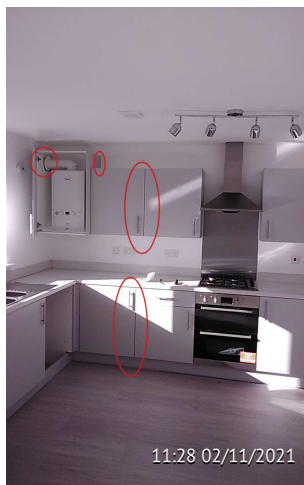
Kitchen

Boiler flue cover not secured
Cabinet doors require adjustment
Mastic missing to top of the cabinet

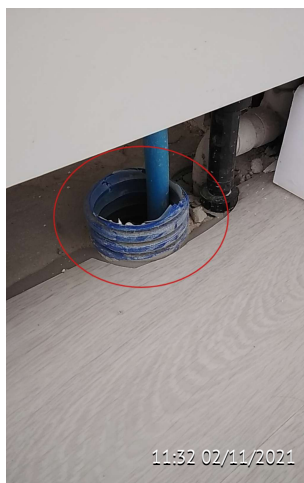
Kitchen

Water main conduit requires filling

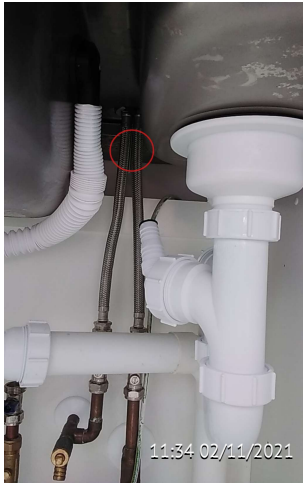
Kitchen

Inconsistent mastic seal to sink cut out aperture

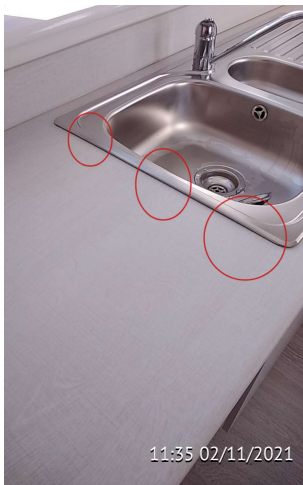
Kitchen

Sink not fully clipped down on the left-hand side

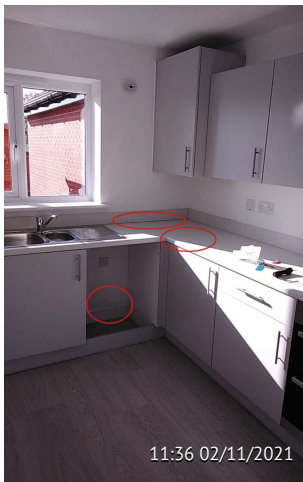
Mitre joint not flush

Kitchen splashback uneven

Marks to wall

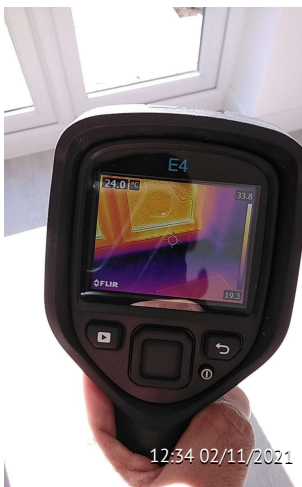
Kitchen

Thermal imaging picked up areas of cold bridging to the French door

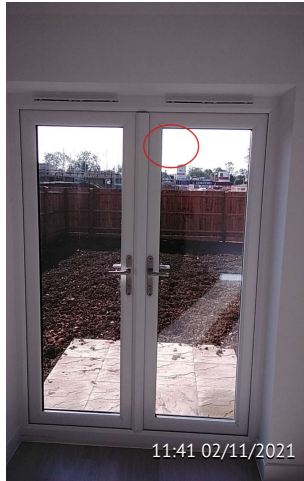
Kitchen

Scratches to glazing

Screws missing to trickle vents

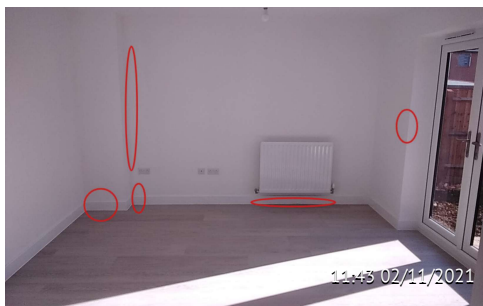
Kitchen

Multiple marks to the wall

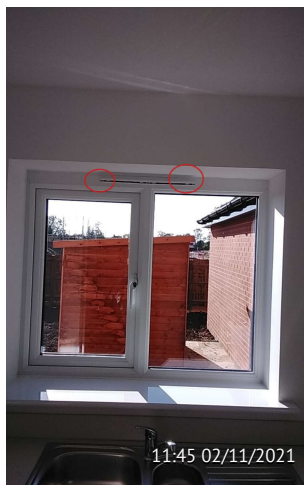
Kitchen

Screws missing to trickle vents

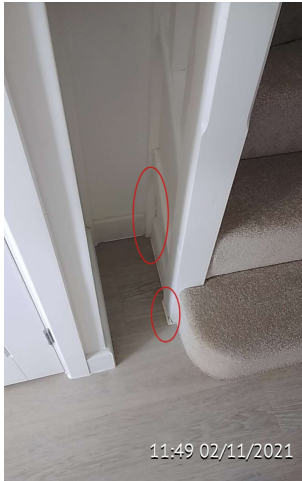
Stairs

Marks to newel post and stairs

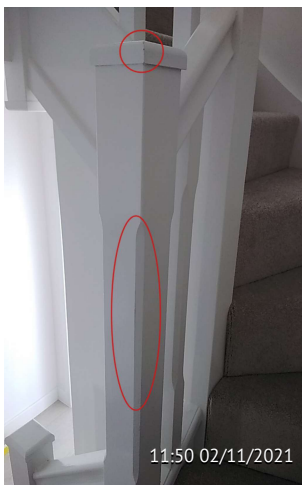
Stairs

Marks to newel post

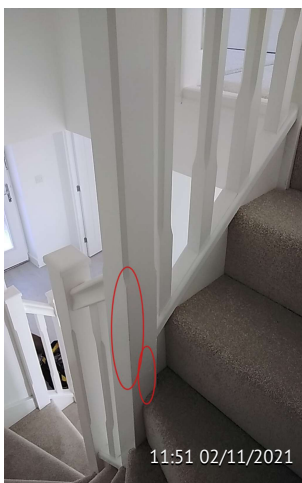
Stairs

Marks to newel post

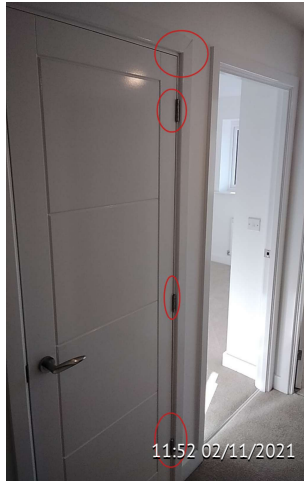
Landing

Paint overspray to hinges
Mark to top right architrave

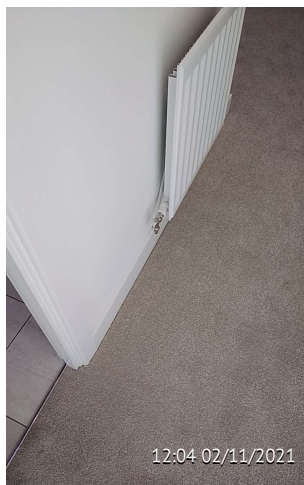
Landing

Paint overspray to the left-hand side radiator valve

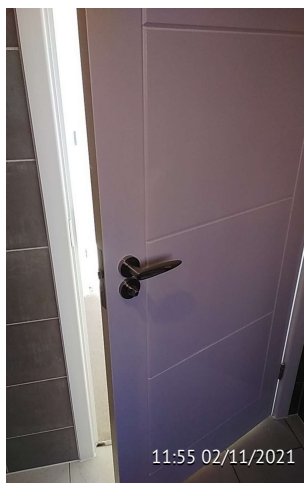
Bathroom

Door rattles in its frame

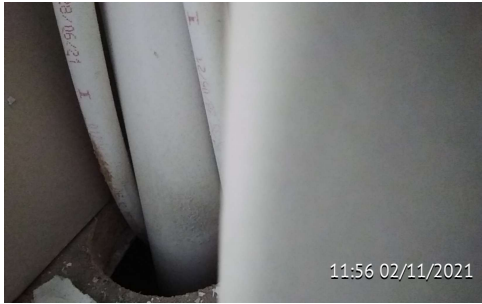
Bathroom

The hole behind the pedestal requires filling

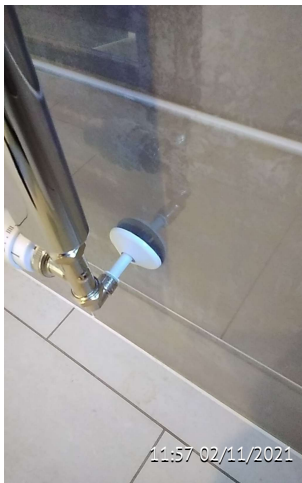
Bathroom

Loose pipe covers on the towel rail

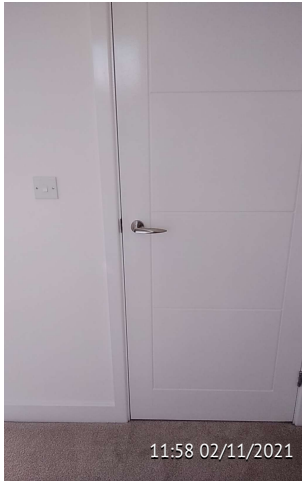
Rear Bedroom Right
Assigned To Carpenter
Door rattles in it's frame

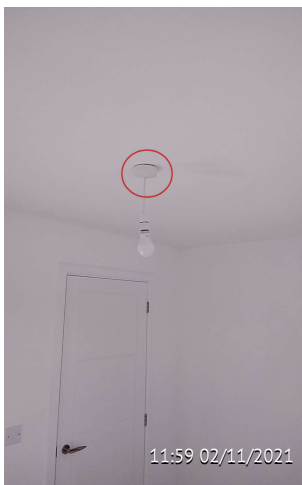
Rear Bedroom Right
Assigned To Building Contractor
The ceiling rose is loose fitting

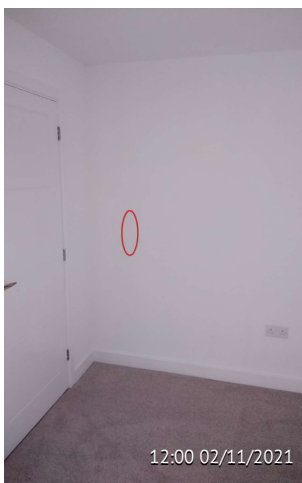
Rear Bedroom Right
Assigned To Decorator
Mark to wall

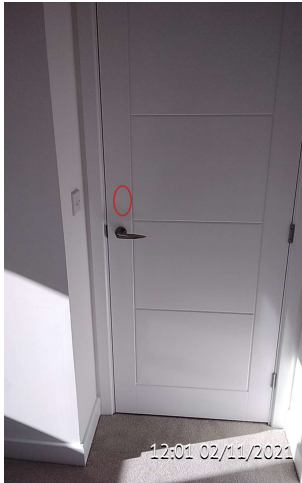
Rear Bedroom Left

Door rattles in its frame
Dripmark to paintwork

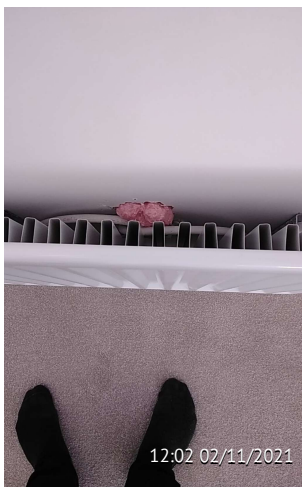
Rear Bedroom Left

Collection point missing to the radiator

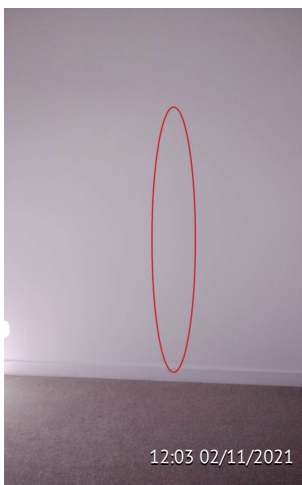
Rear Bedroom Left

Scratches in wall

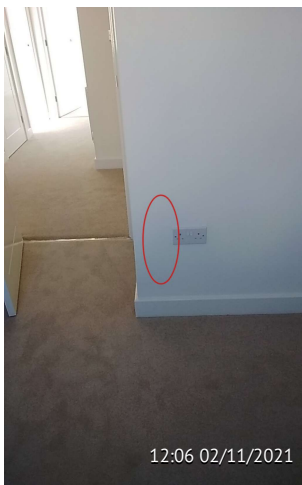
Front Bedroom Left

Marks to wall round socket

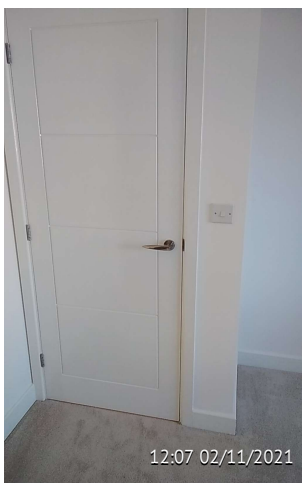
Master Bedroom

Door rattles in it's frame

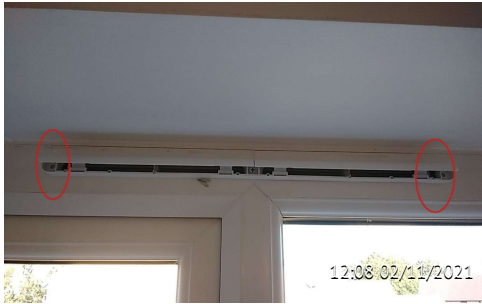
Master Bedroom

Throughout the property, there are missing screws to the trickle vents on all windows and doors

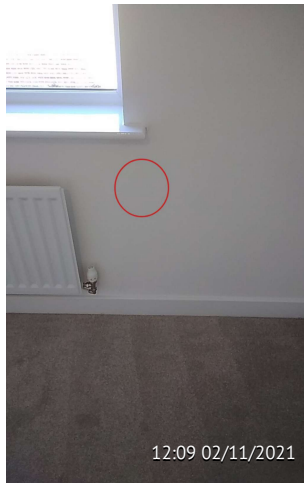
Master Bedroom

Mark to wall

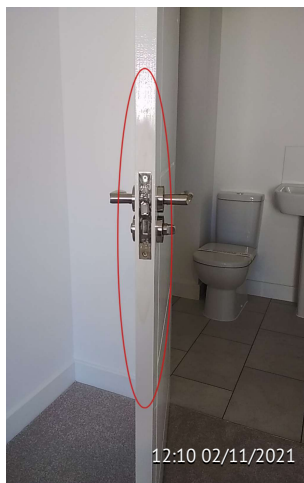
Master Bedroom Ensuite

Poor finish to door edge

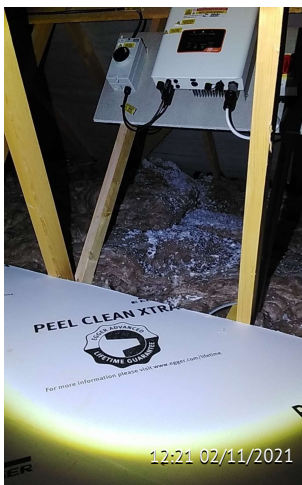
Loft

A large amount of shredded material indicates the possibility of rodents. Builder, please investigate

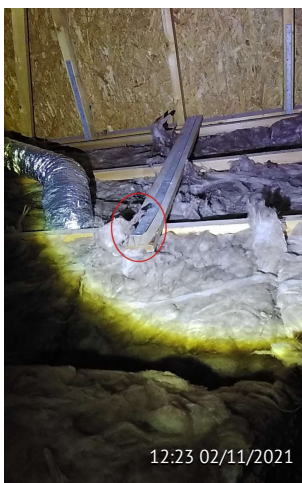
Loft

Unsecured restraint strap
