22 Sample Drive , Sampleland

SAMPLE DEVELOPMENTS

Wednesday, 02 February 2022

105 defects detected

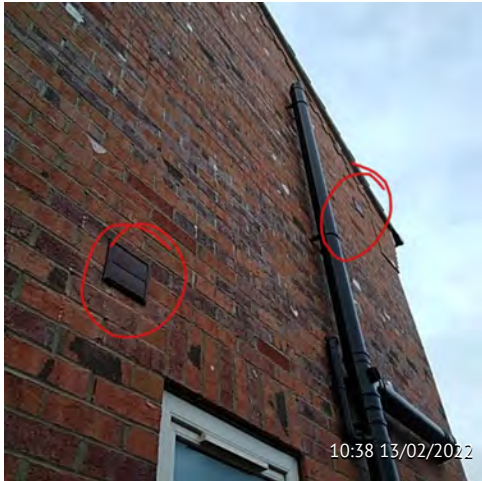
13 LHS Elevation

Sealant missing

Clip cables in position

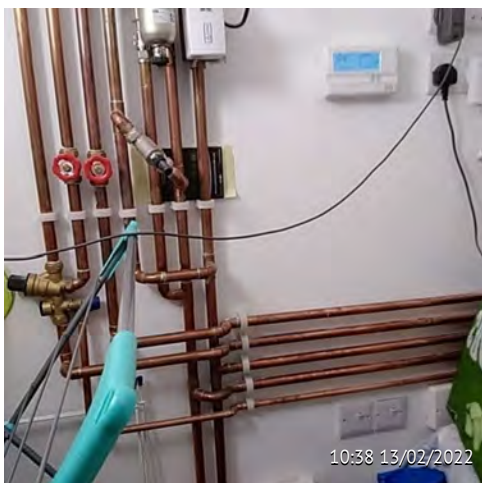
34 Lounge

Hot water running off immersion system only

There is no insulation fitted to the hot side cylinder pipework

Installation has no signed certificate on side of unventilated cylinder

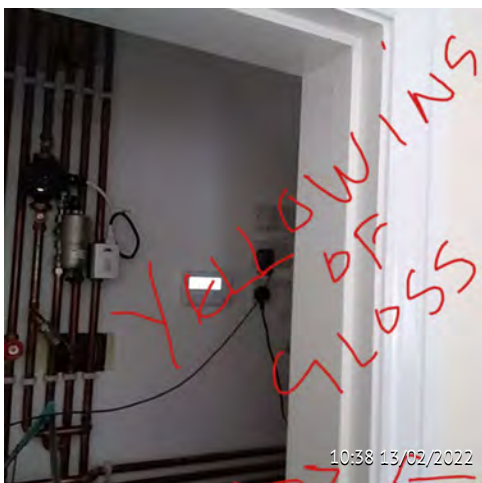
39 Typical Door Frame

Note premature Yellowing of paint finish.....caused by lack of daylight to paint , builder should choose paint formulations that can last the defects liability period

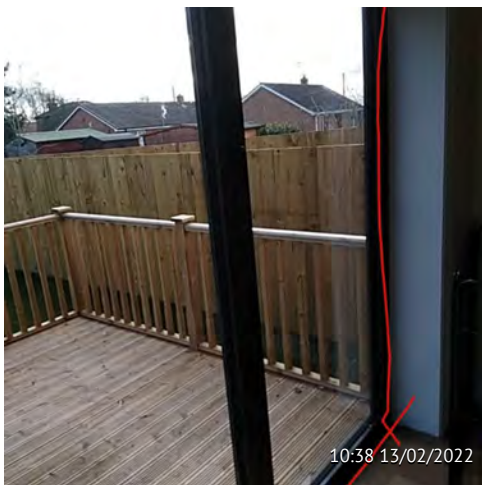
48 Dining Room

Gasket/ trim missing

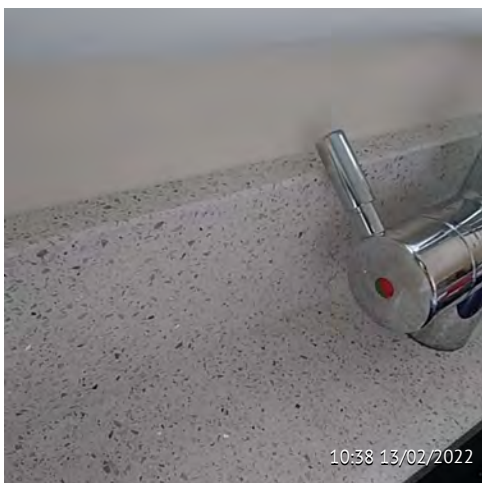
64 Kitchen

Tap loose

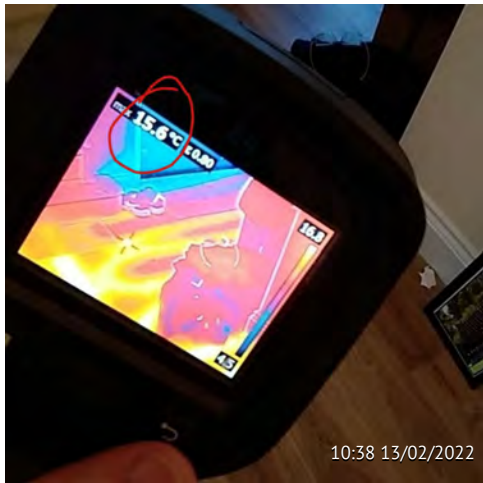
65 Kitchen

Hot tap operation inhibited

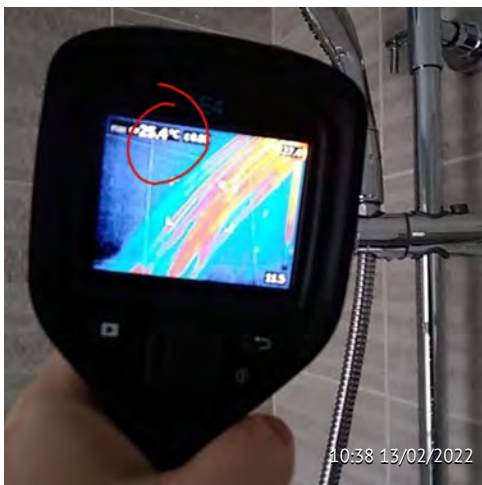
72 Bathroom
trade Plumber
Leak from handset

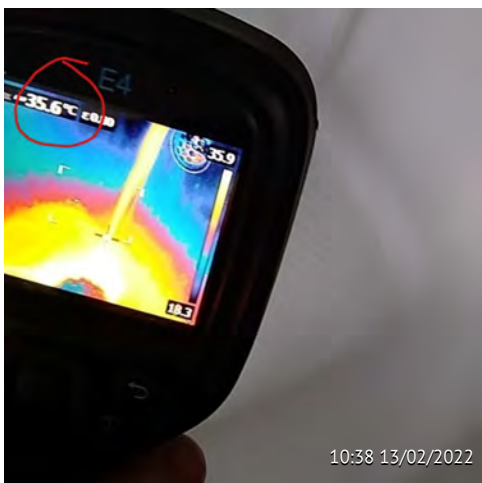
74 Shower
trade Plumber
Low water temp

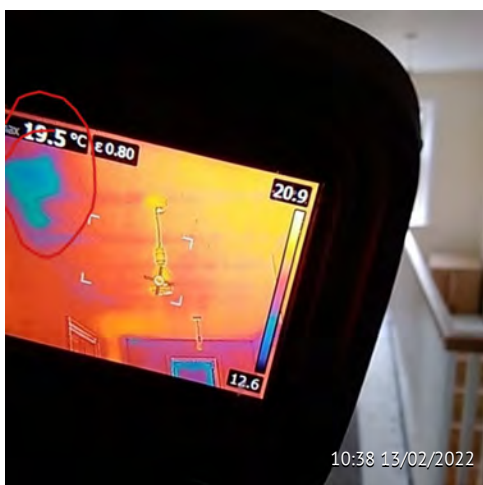
108 Landing
trade Plumber
Low radiator temp
Radiator requires bleeding
