Inspection 17/02/2023 Copy 4 Bedroom, Example Developers

22 Example Close

New Build Inspections

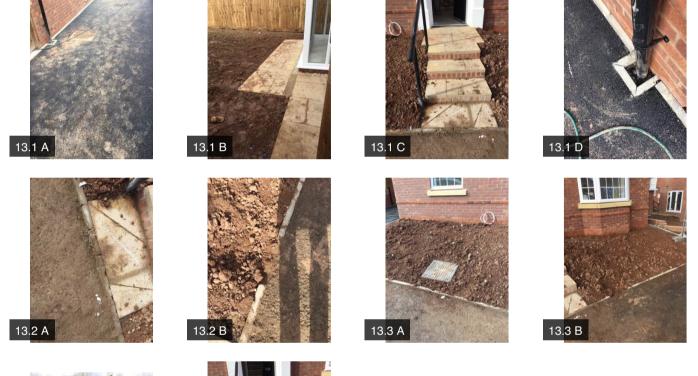
13.3 Lawns		Fail			
	Action	Assignee	Due Date	Complete?	Action Comments
	Action 1	Landscaper	N/A	No	Landscaping has yet to have been fully completed to this property at the time of inspection
13.4 Steps		Pass			
	Action	Assignee	Due Date	Complete?	Action Comments
		U U	Buo Buio	complete.	Action Comments

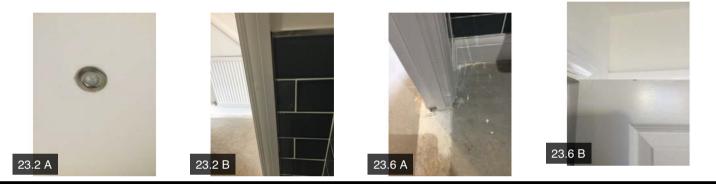
23.1 Plastering & Dry Lining		Pass			
23.2 Finishes	23.2 Finishes				
	Action	Assignee	Due Date	Complete?	Action Comments
	Action 1	Decorator	N/A	No	Poor decorative finishing around the spotlight
	Action 2	Builder	N/A	No	Sealant work required at the junction of wall tiling and door architrave and tiling
23.3 Floors	23.3 Floors				
23.4 Windows	23.4 Windows				
23.5 Skirting / Pl	linths	Pass			
23.6 Doors		Fail			
	Action	Assignee	Due Date	Complete?	Action Comments
	Action 1	Decorator	N/A	No	Poor finish to the inside of the downstairs WC door frame
	Action 2	Carpenter	N/A	No	Chip noted to the rear face of the downstairs WC door
23.7 Lights		Pass			
23.8 Sockets		N/A

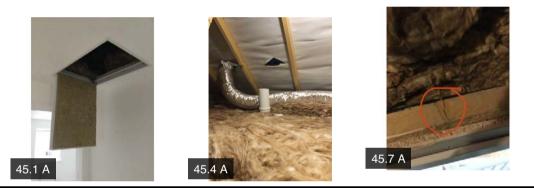
Action 1	Builder	N/A	No	At the time of inspection I could not close or lock the loft hatch builder please investigate
45.2 Ladder		N/A			
45.3 Felt		Pass			
45.4 Ducting		Fail			
	Action	Assignee	Due Date	Complete?	Action Comments
	Action 1	Plumber	N/A	No	It appears as though the durgo has yet to be fitted at the time of inspection
45.5 Insulation		Pass			
45.6 Cable & Wires		Pass			
45.7 Timbers		Pass			
	Action	Assignee	Due Date	Complete?	Action Comments
	Action 1	Carpenter	N/A	No	Split noted around the loft hatch , builder please make good
45.8 Cold Water Tanks		N/A
