Sample Report

Tuesday, 02 November 2021

78 Issues Identified

New Build Inspections

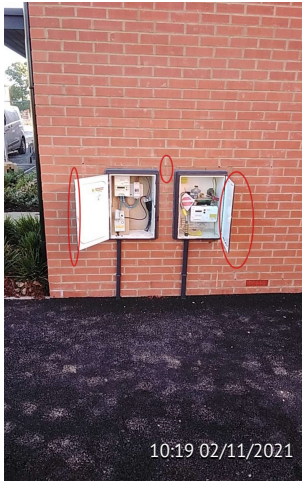
Exterior Right

Edges of meter boxes require decoration
Blocked weep vent

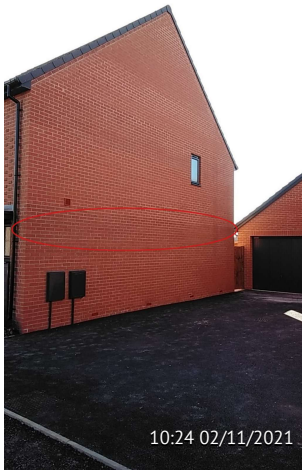
Exterior Right

Brick batching problem resulting in visible differences of colour

Pointing to the gable differed in colour

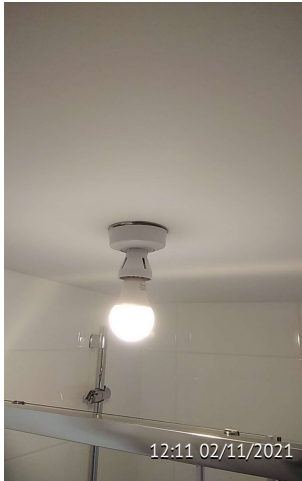
Master Bedroom Ensuite

Loose-fitting ceiling rose
