22 Sample Drive , Sampleland

SAMPLE DEVELOPMENTS

Wednesday, 02 February 2022

105 defects detected

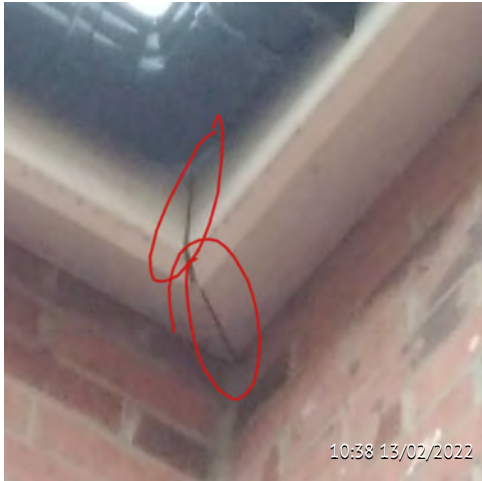
8 Fascia Above Front Door

Fascia and soffit jointer have not been used at joints

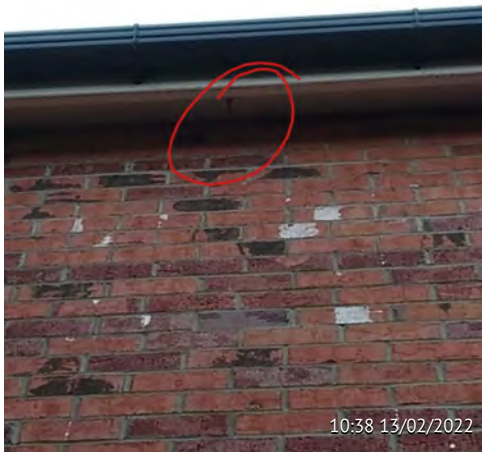
10 Front LHS Elevation

Soffit jointer not used

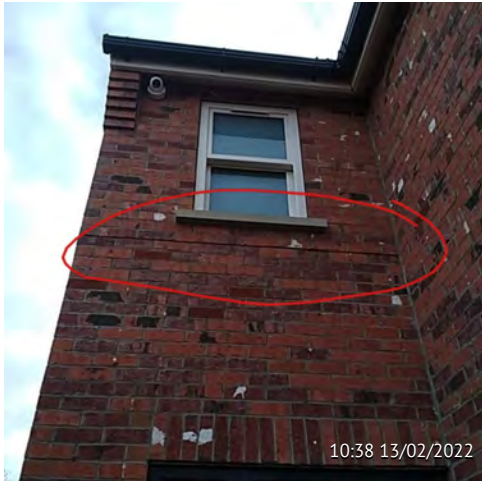
11 Front Elevation

Pointing missing in brickwork

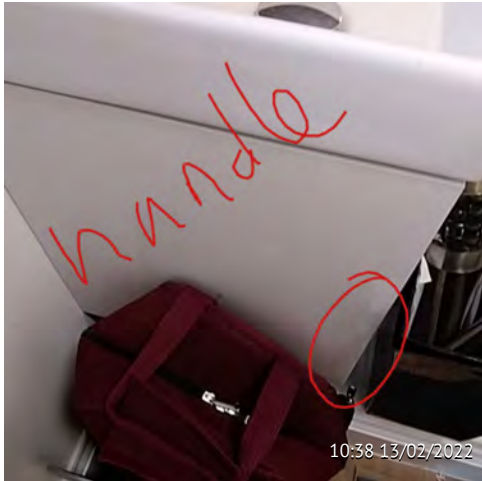
26 WC

Handle missing from the door

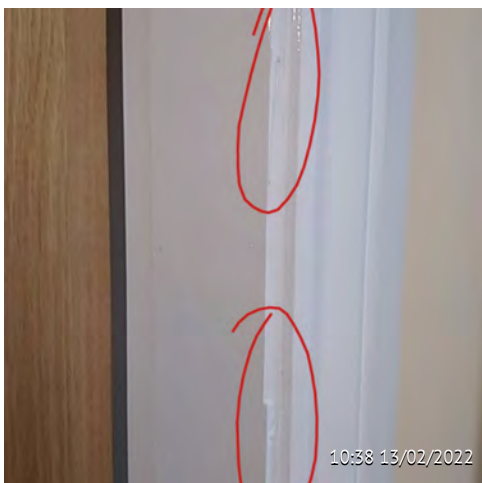
28 Hallway

Damage to door frame simply decorated

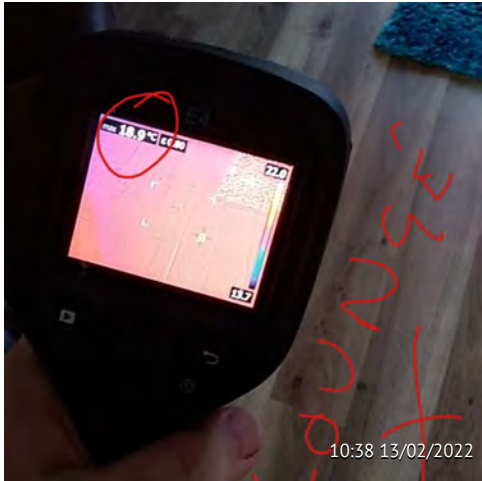
45 Lounge

The lounge floor whilst reading 18degrees on the cameradoes not appear to be operating at the same level as dining room

Stat for room is set at 18degrees, inspector could not raise the temperature above this point

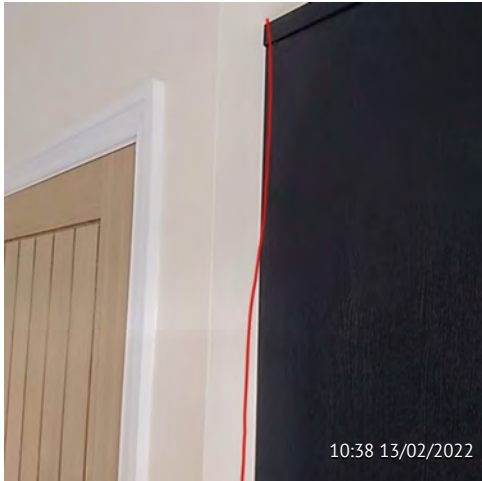
51 kitchen
trade Decorator
Mastic seal required

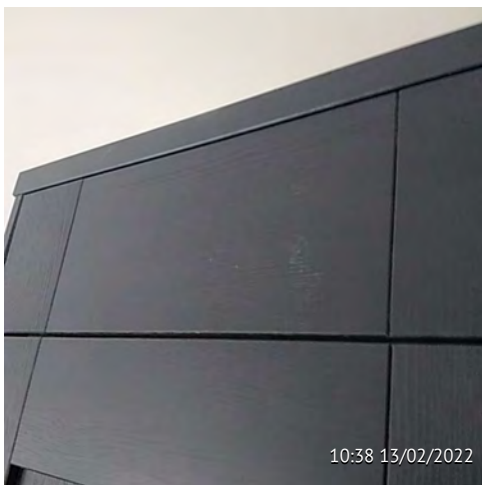
55 Kitchen

Marks in cabinet door

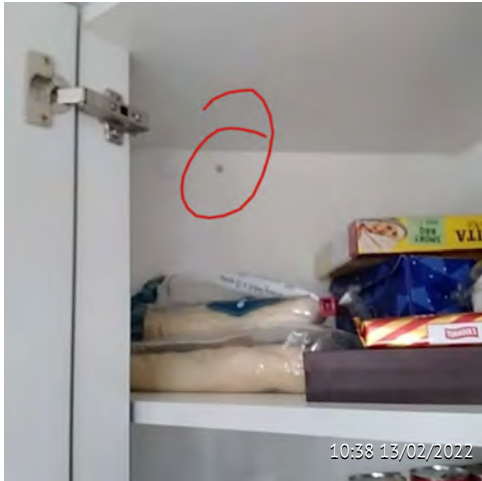
57 Kitchen

Cover cap missing

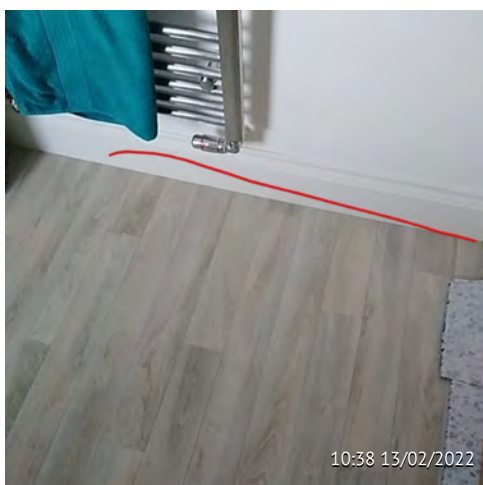
71 Bathroom

Mastic sealant required around the perimeter of the room

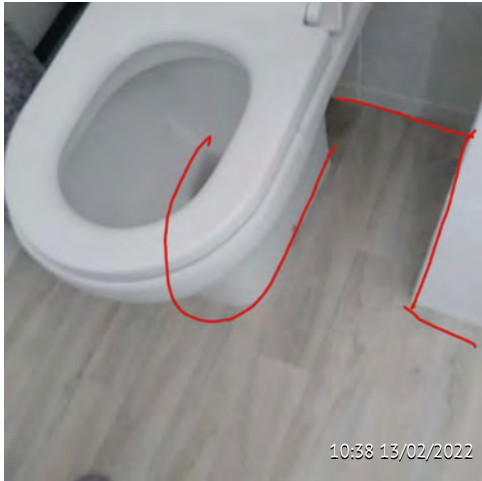
77 Bathroom

Mastic sealant required

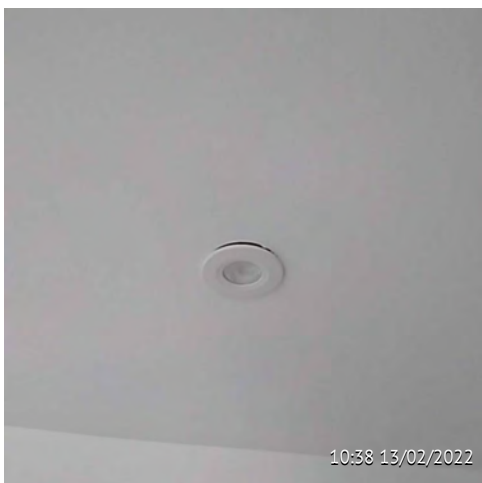
80 Bathroom

Make good decorative finish to ceiling

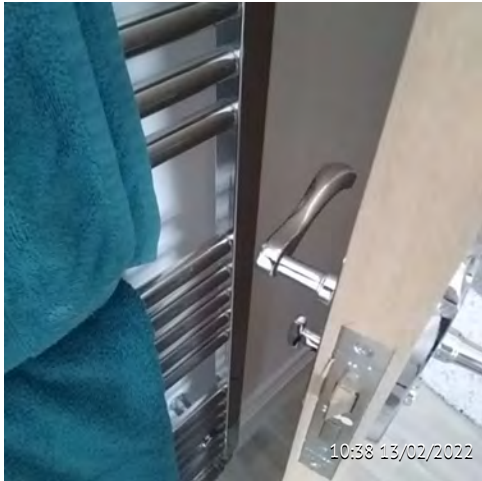
81 Bathroom
trade Carpenter
Door stop required

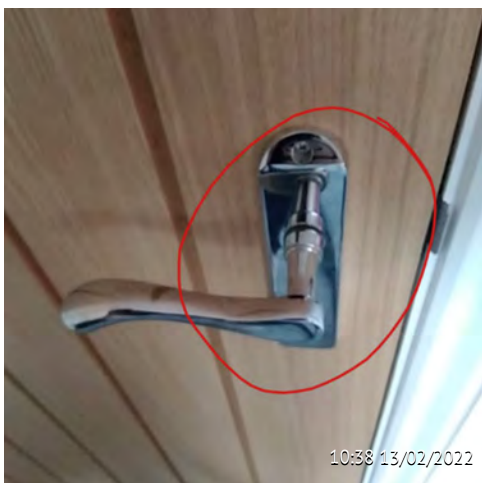
83 Bedroom Rear
trade Carpenter
Door rattles in the frame

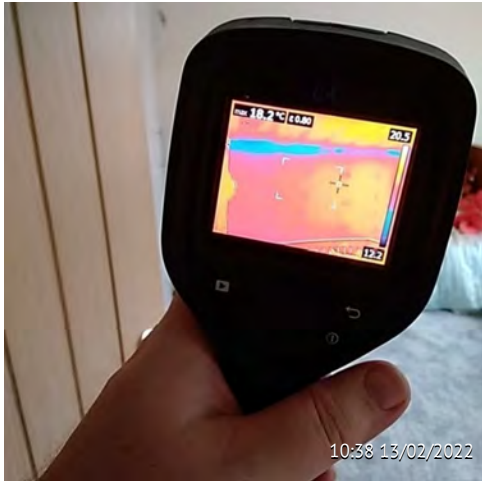
110 Front Bedroom Ceiling

Builder to investigate and comment on results of thermal imagingall rooms of this side of the building show a heat loss in the loft along the line where wall meets ceiling

Suggests insulation is not consistent at this point in loft

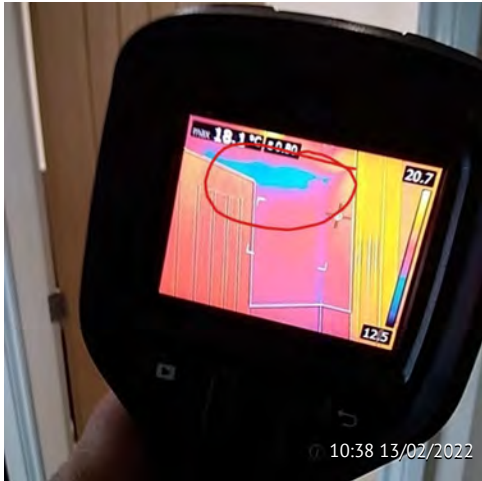
89 Ensuite

Builder to investigate and comment on results of thermal imagingall rooms of this side of the building show a heat loss in the loft along the line where wall meets ceiling

Suggests insulation is not consistent at this point in loft

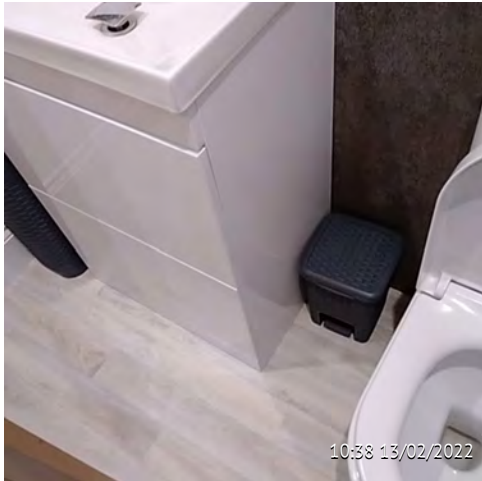
92 Ensuite

Mastic sealant required to all areas shown in photograph

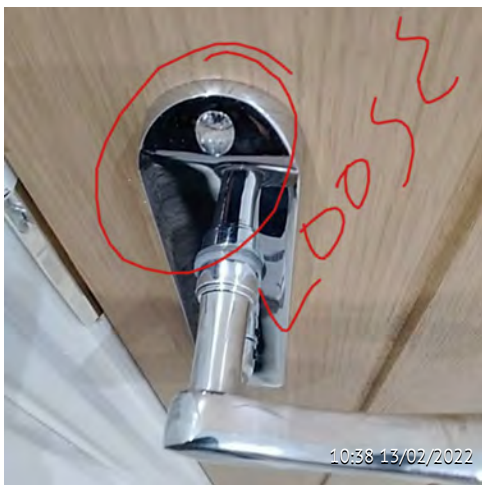
93 Ensuite

Handle becoming loose

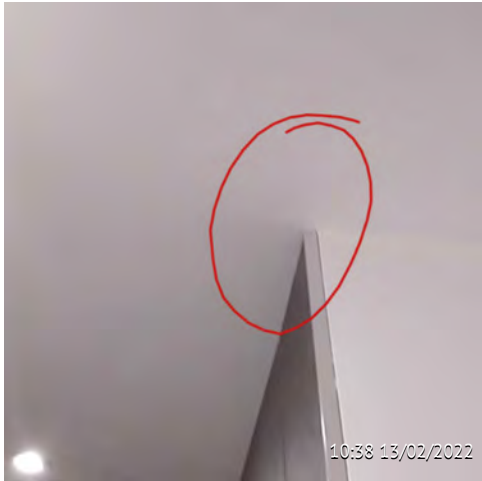
95 Ensuite

Poor decorative finish as shown in photograph

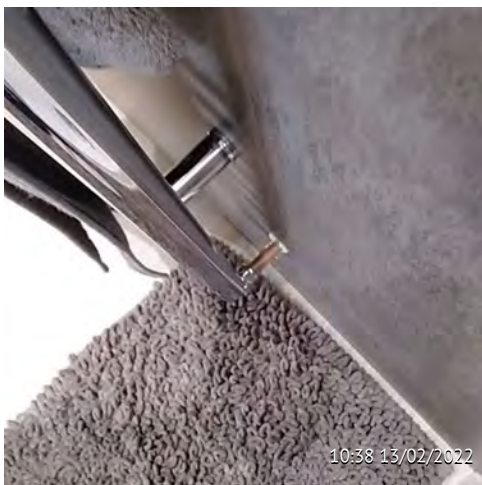
96 Ensuite

Paint radiator tails

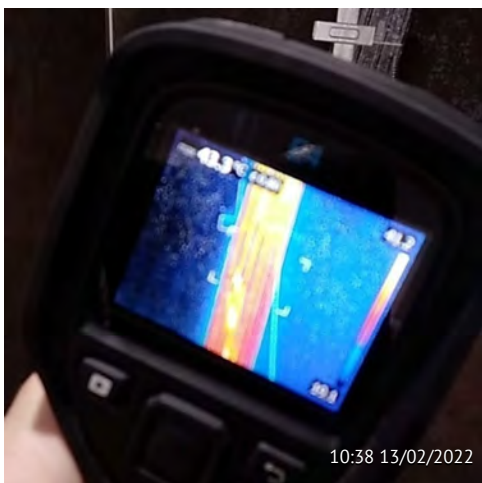
97 Ensuite

Shower temp lowbut better than bathroom

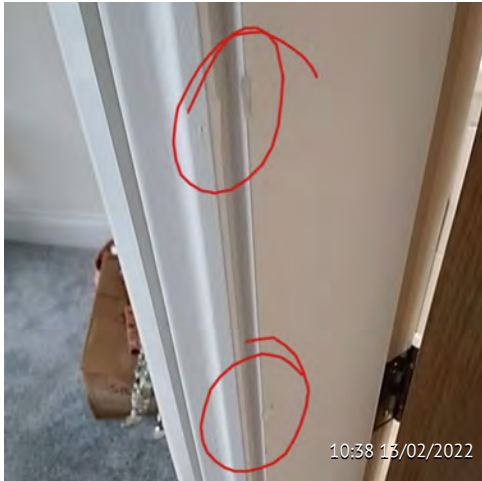
98 Ensuite

Example of typical damage to door frame

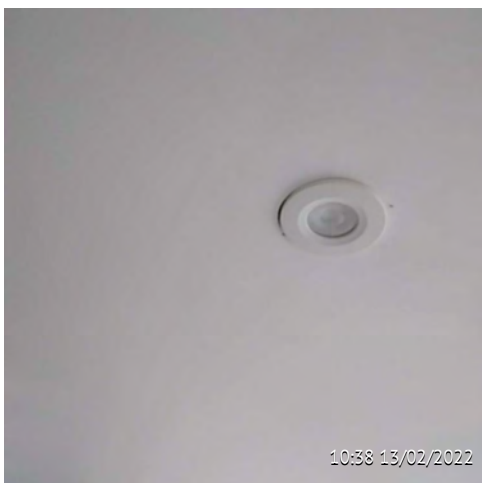
100 Bedroom Front

Make good decorative area shown in photograph

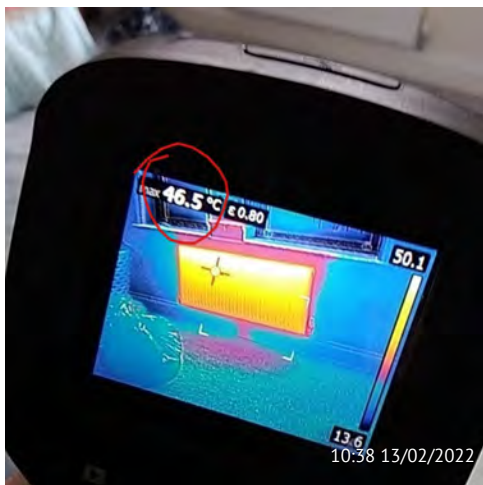
102 Bedroom Front

Radiator temp low ...setting on full

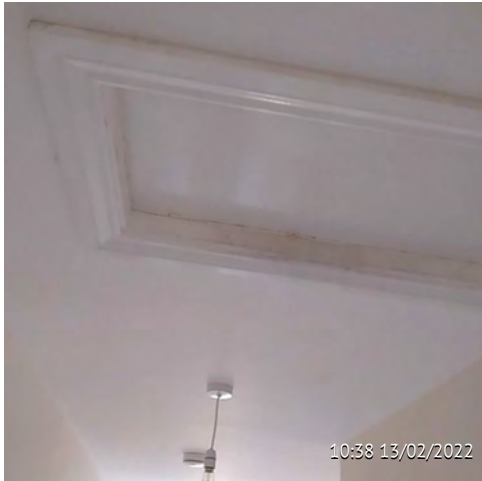
104 Loft Hatch

Unusual sizemaking access and use somewhat limited

Finishing Around hatch and frame required attention

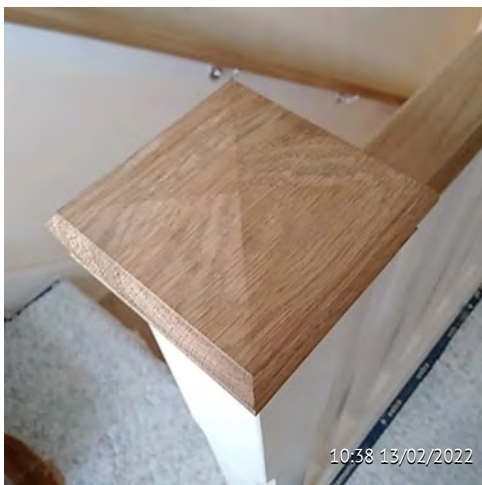
105 Landing

Newel caps require sanding down and final decorative finish

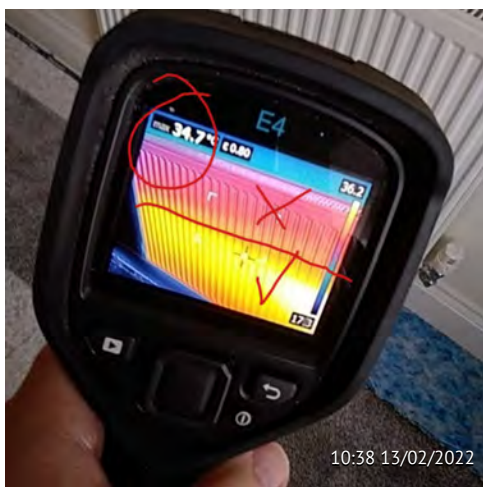
108 Landing
trade Plumber
Low radiator temp
Radiator requires bleeding
